MOUNT EVERETT ACADEMY  
STABILIZATION AND ADA IMPROVEMENTS

**ADDENDUM TWO**

**MOUNT EVERETT ACADEMY/EGREMONT FREE LIBRARY  
SOUTH EGREMONT, MASSACHUSETTS**

**EVELYN COLE SMITH ARCHITECTS, LLC**

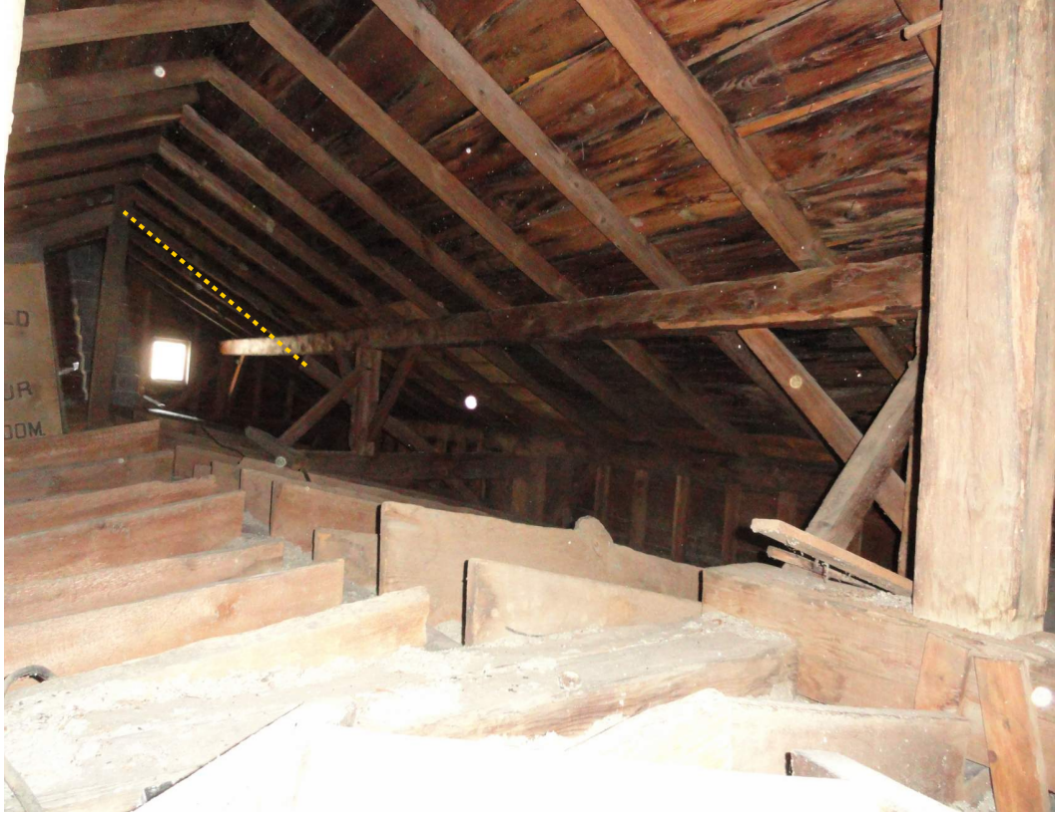
Figure 1: Attic Photo showing brace to be repaired.

**Response:** The eastern attic truss brace was partially removed and should be replaced with sistered 2 x 8 Douglas fir members, through bolted to the lower partial brace and at the upper vertical member. Consider the length of the missing element to be 12' for the purpose of bidding. See photo below.

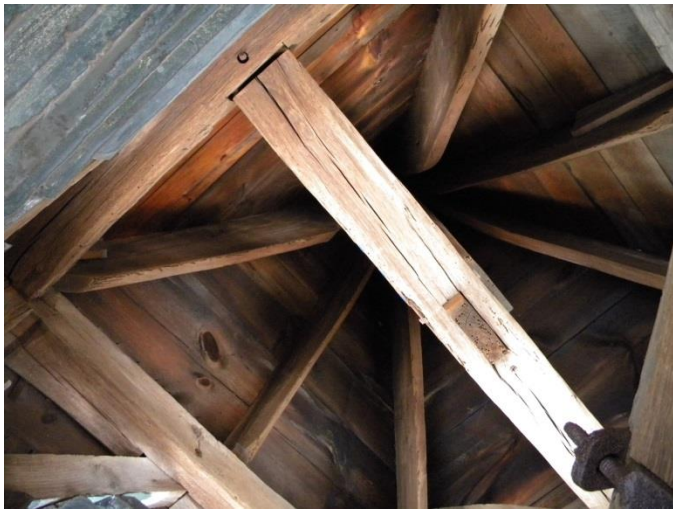
Belfry Interior – looking up to underside of Roof

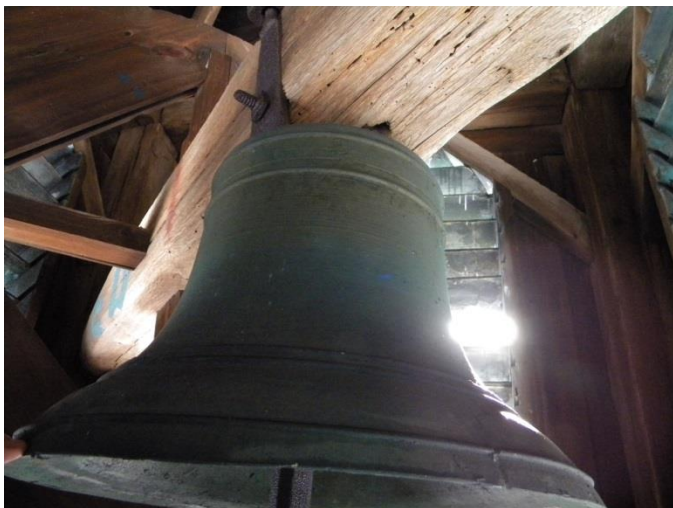
Bell and support framing

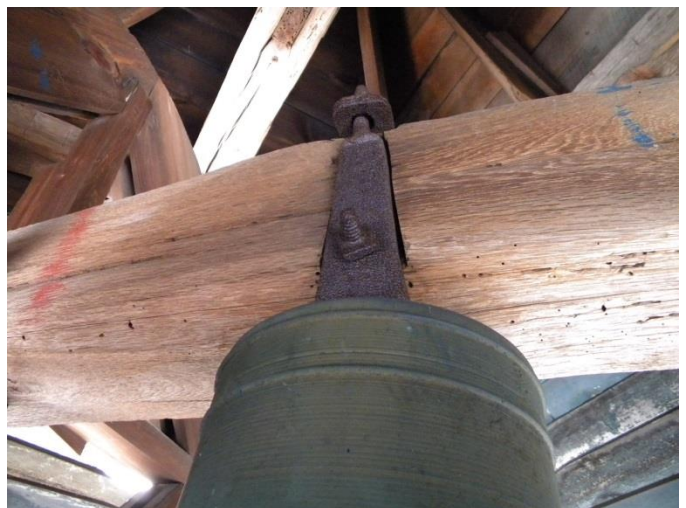
Bell and support framing

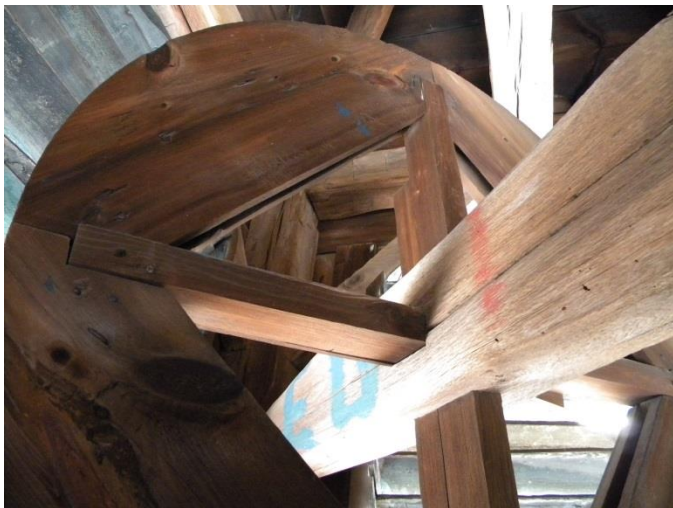
Bell Wheel

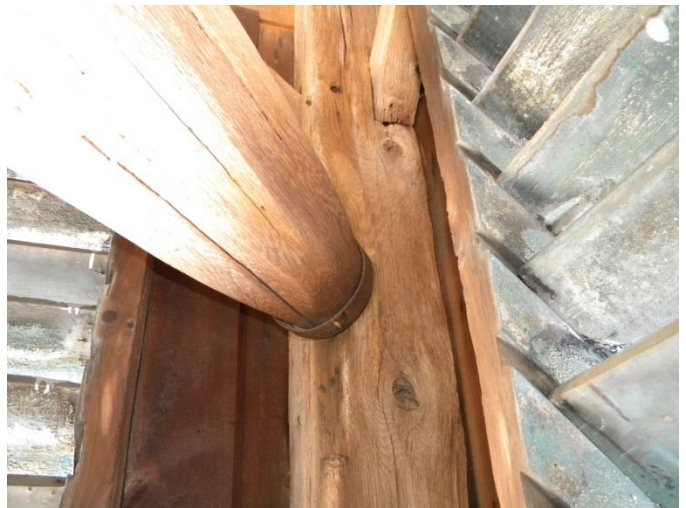
Bell Support Framing and Belfry Corner Post

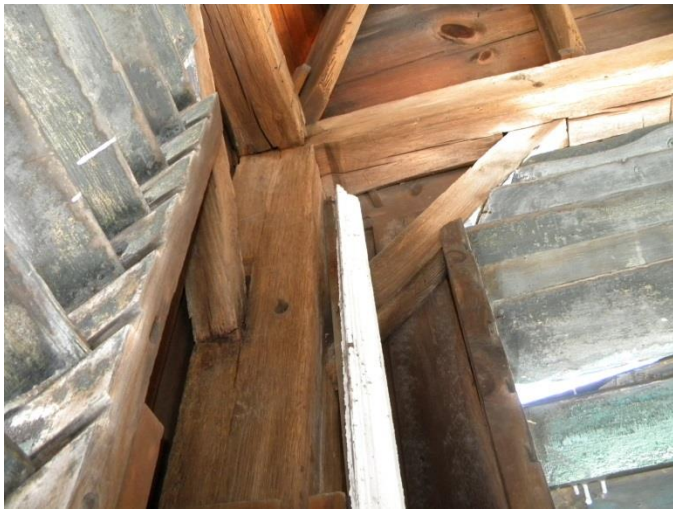
Belfry Post and Louvers

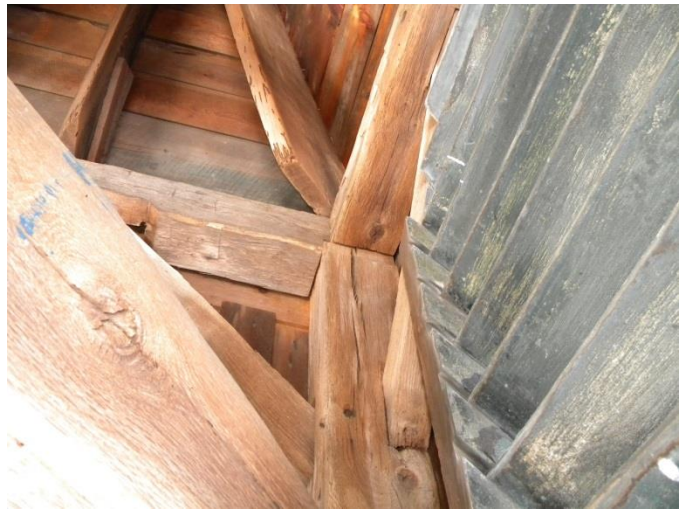
Belfry Corner Post and Louvers

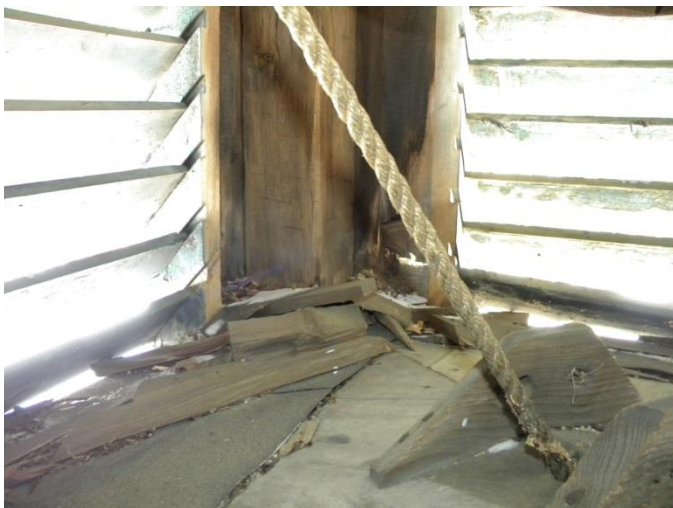
Belfry Post Base

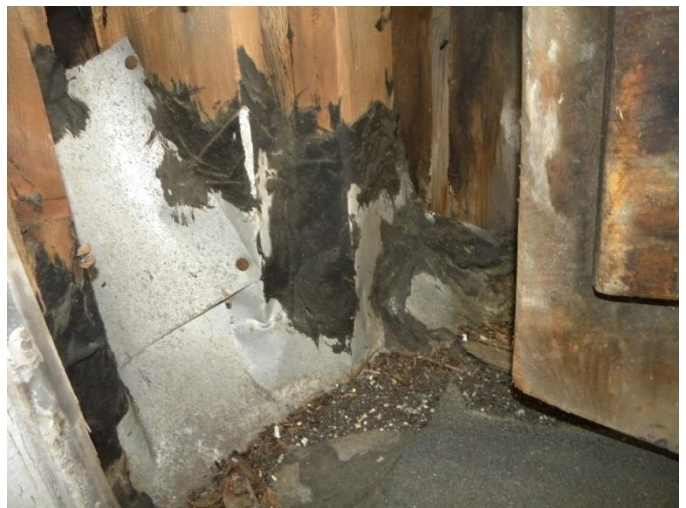
Belfry Post Base

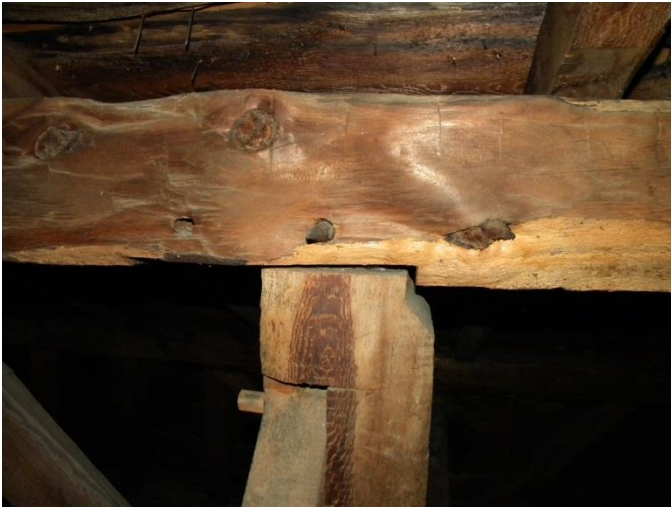
Typical Roof Framing in Attic

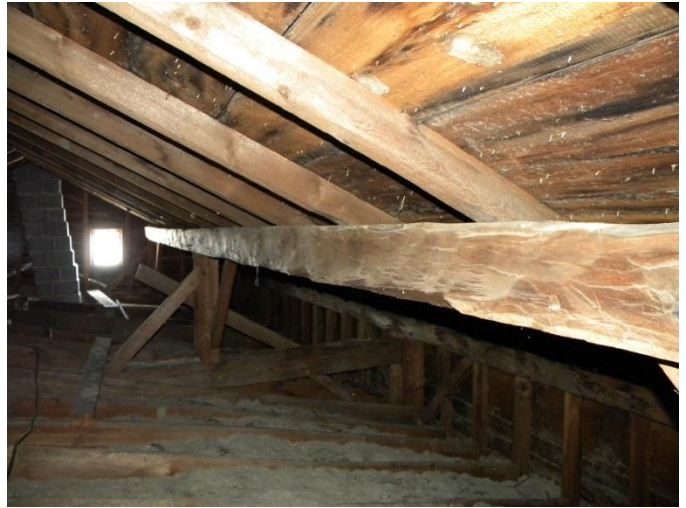
Typical Roof Framing in Attic

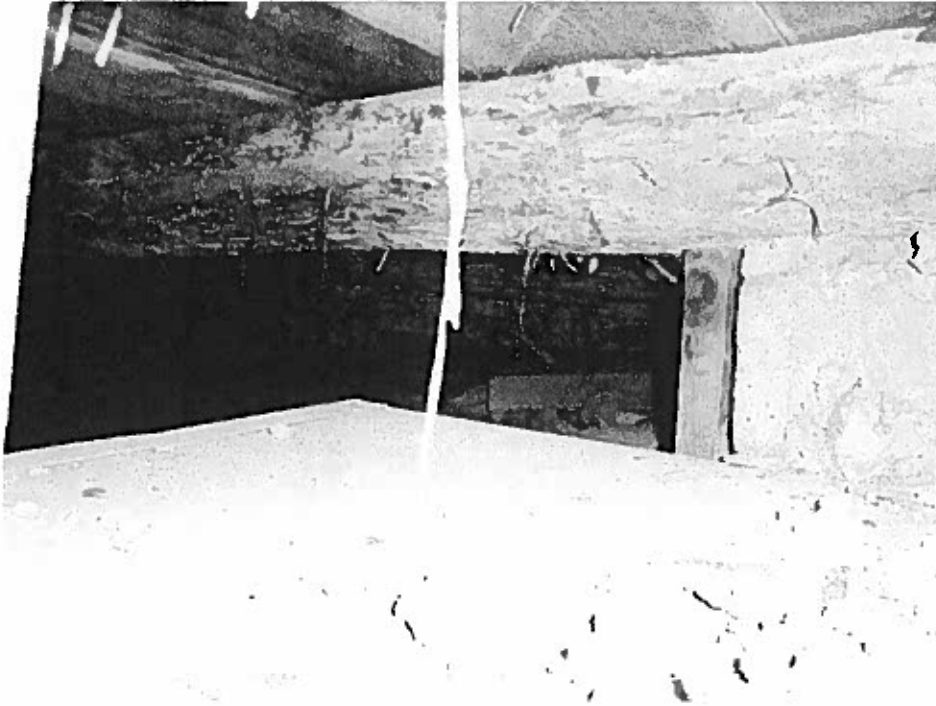
Underside of flooring system at east end of building. Hand hewn floor joist, decking above. Note support at east end of joist.

Looking northwest

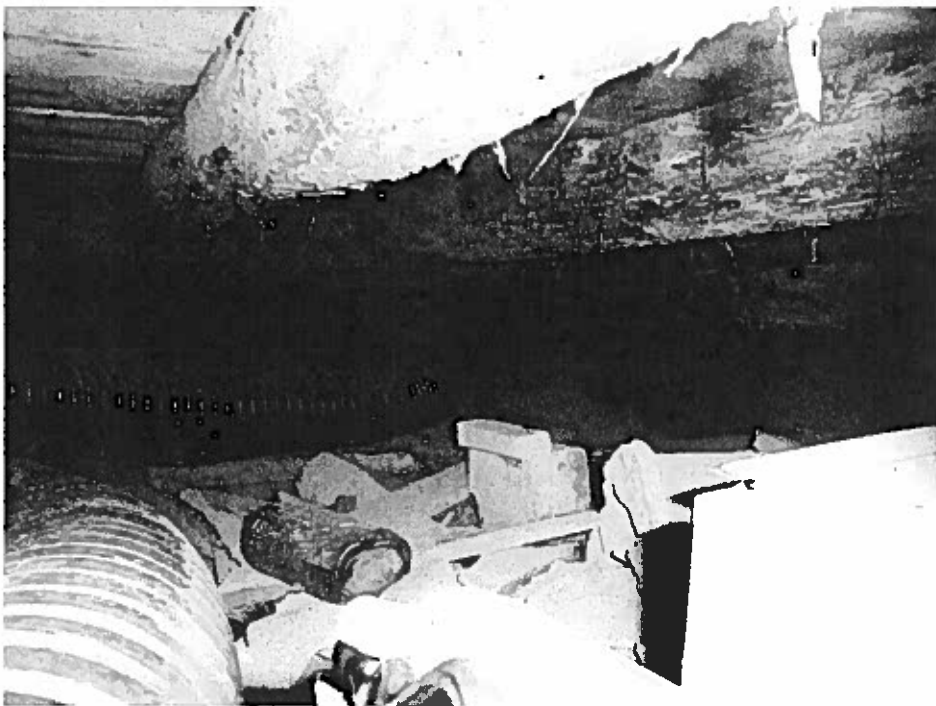
Underside of flooring system at east end of building. Hand hewn floor joist supported by beam, decking above. Heating duct temporarily removed.

Looking west

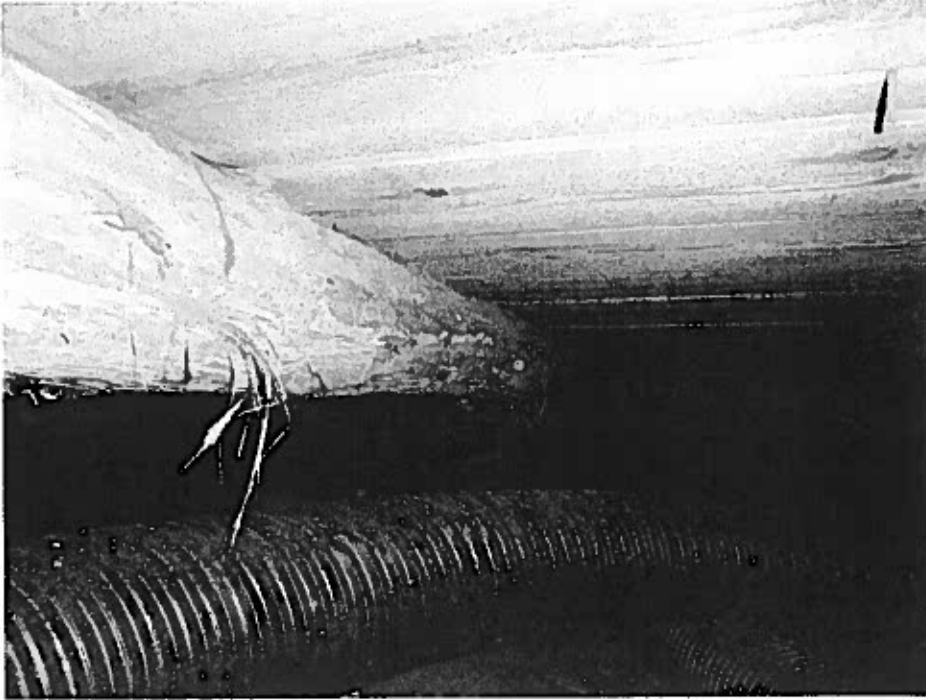
Underside of flooring system at east end of building. Hand hewn floor joist, decking above. Beam and pier in background. Heating duct in foreground has been temporarily removed.

Looking west

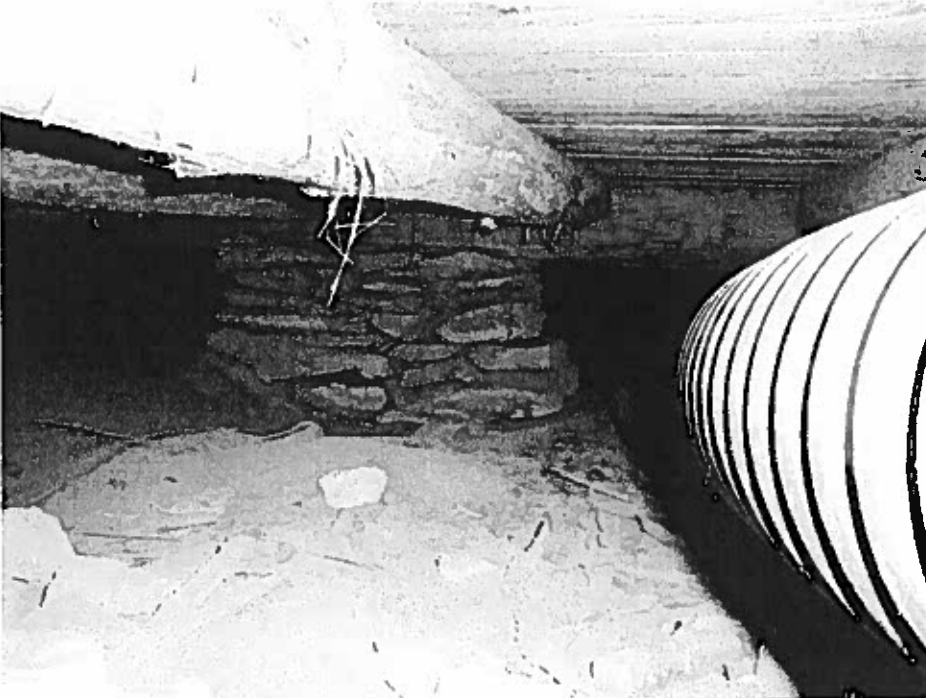
Underside of flooring and support pier at east end. Pier is at approximate mid-span of beam.

Looking west

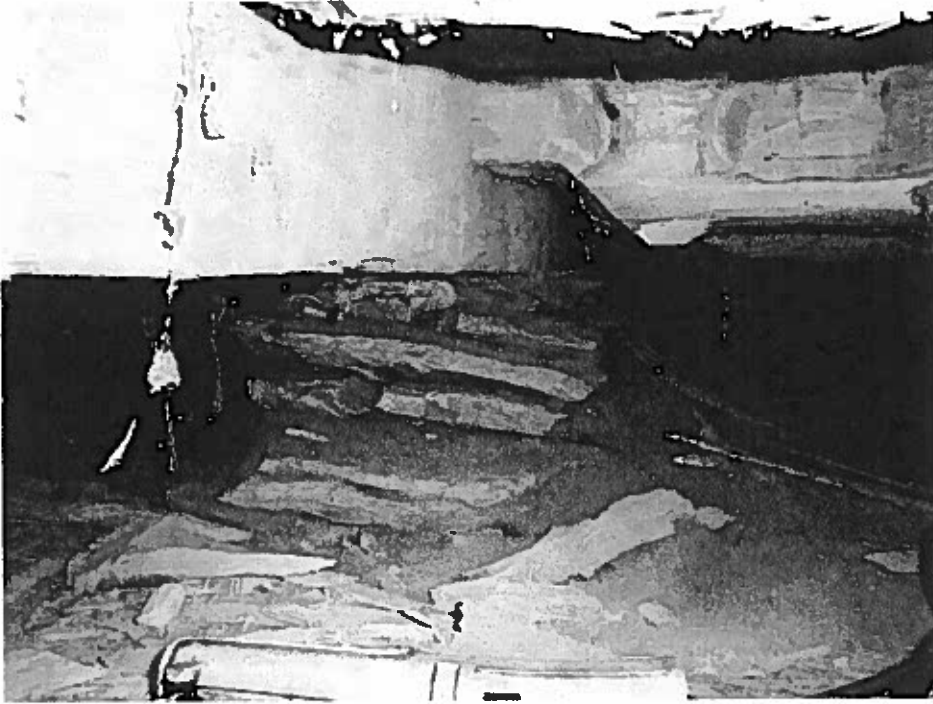
Underside of flooring system and west pier. Pier is under center of west beam.

Looking south

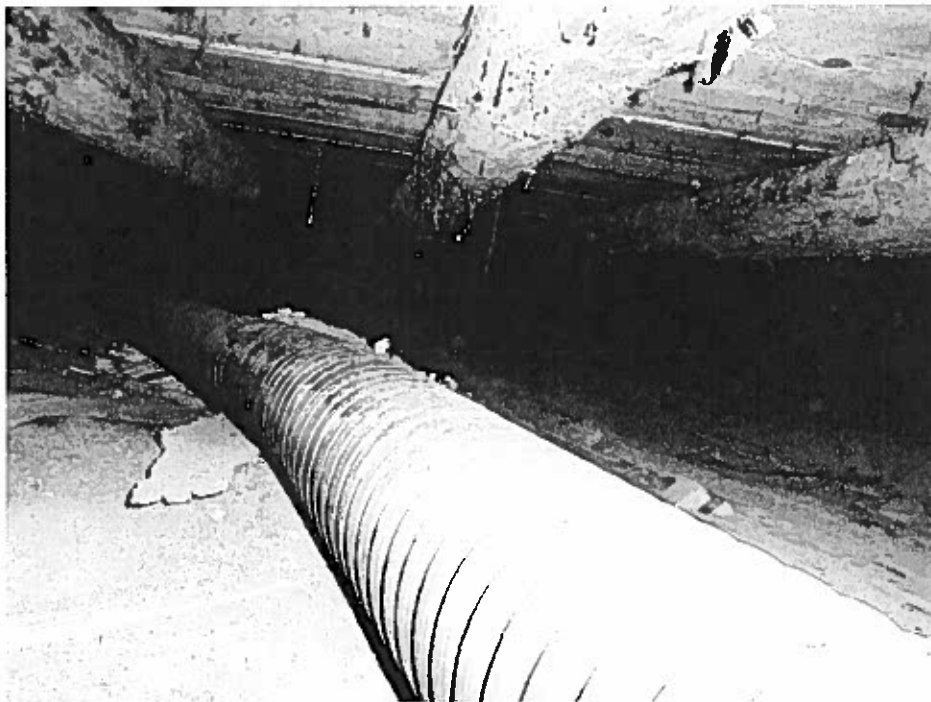
Underside of flooring system at west end of building. Heating duct is in foreground.

Looking east

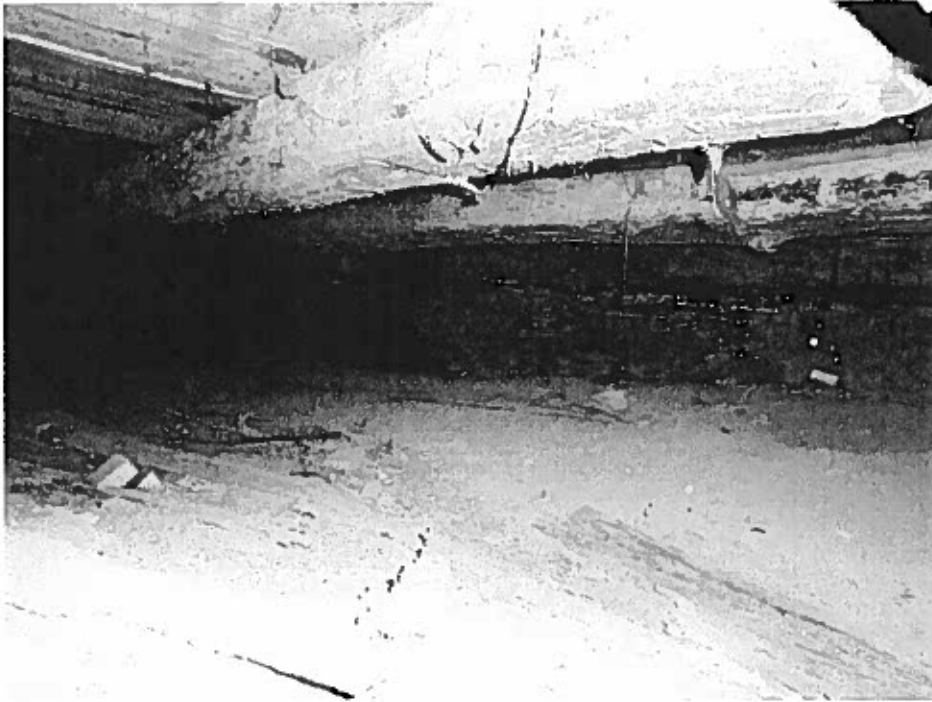
**Underside of flooring system at west end. Note delamination of floor joist members.**

**Looking southeast.**

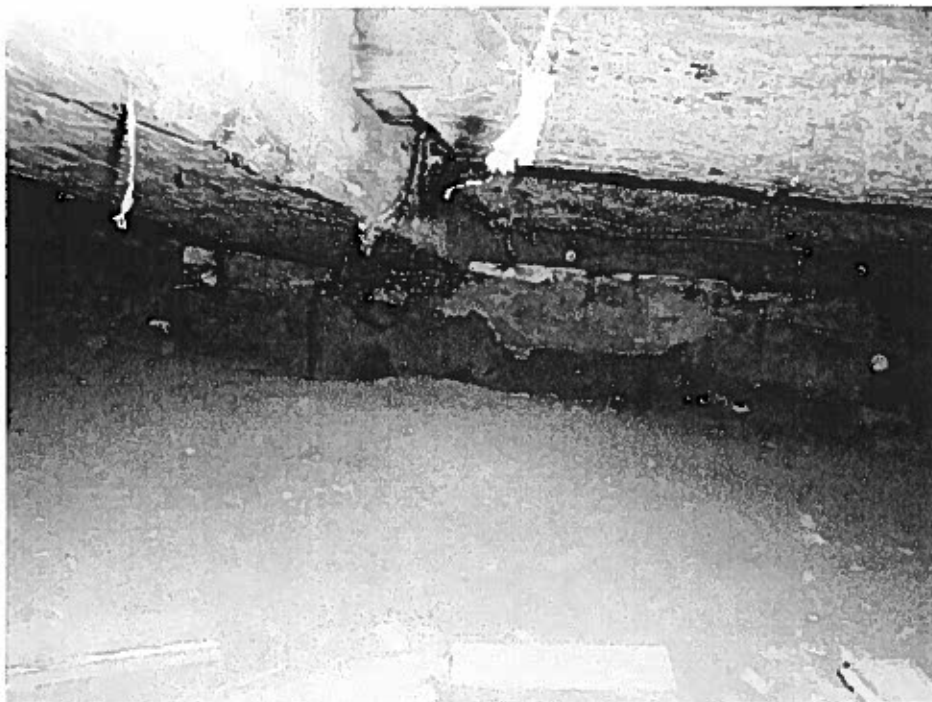
**Underside of flooring system at west end. Hand hewn floor joists, decking above. South side of west beam, south foundation wall beyond.**

**Looking south.**

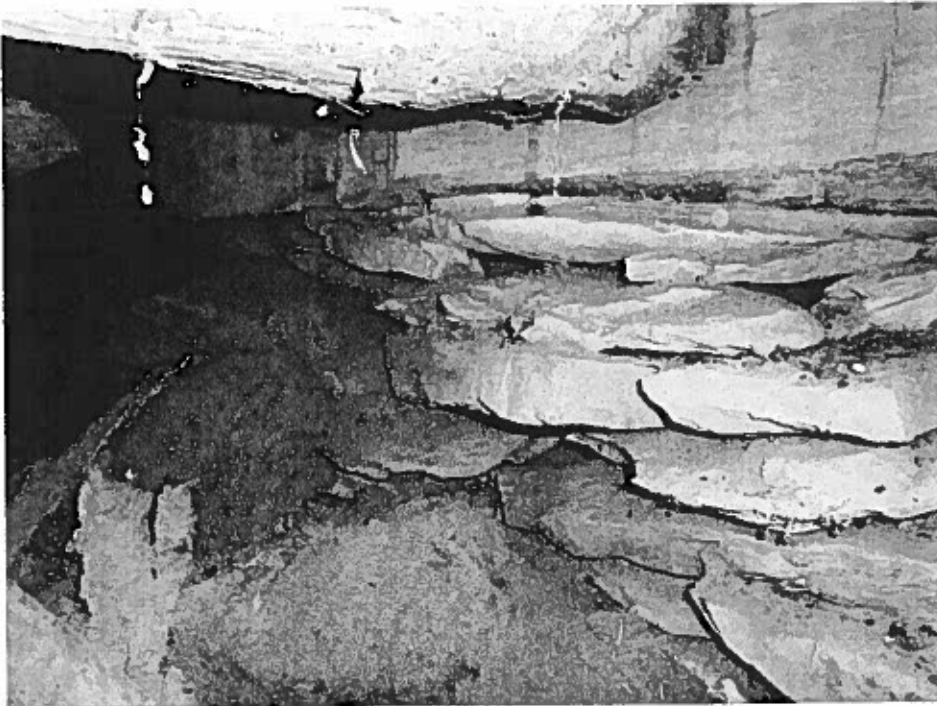
Underside of flooring system at west pier supporting west beam.

Looking northeast
